# SODBURY

## Survey Report : Level 3

123 Sample Street, Bristol, BS1 2XY

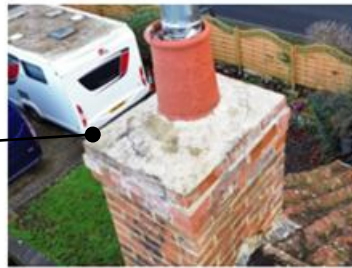
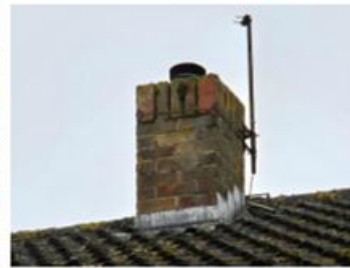
The chimney stacks are generally in fair condition. The following defects / issues were identified during my inspection:

- The cement flashing at the top of the chimney stack is cracked, which can lead to water ingress and can lead to the chimney pots coming loose in high winds, which is a potential safety hazard.
- The brickwork at the top of the rear stack is frost damaged and crumbling.

| Urgency | Action |
|---|---|
| <b>B</b> | The cracked/damaged flashing to the front chimney stack should be hacked off and renewed with new cement mortar. |
| <b>C</b> | The rear chimney should be repointed and the mortar 'flashing' around the flue on the top of the chimney should be renewed to preserve weathertightness and prevent further deterioration. |

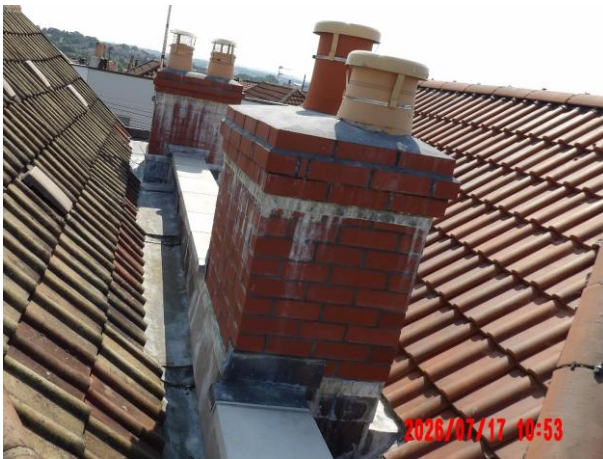
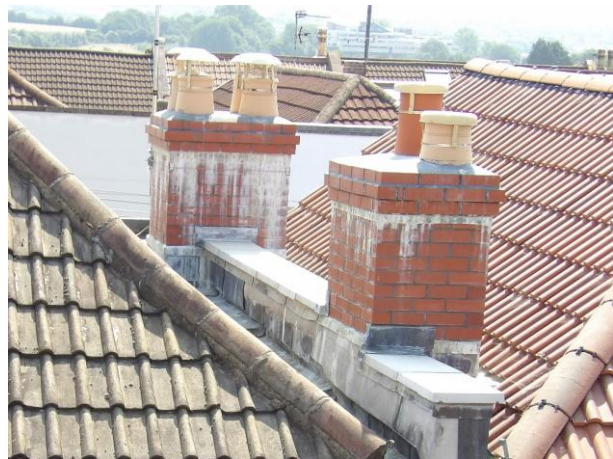
The chimney is generally in good condition having been recently re-built to a good standard. No significant defects were identified during my inspection. There is some white staining on the brickwork, called efflorescence. This is normal and is not of concern.

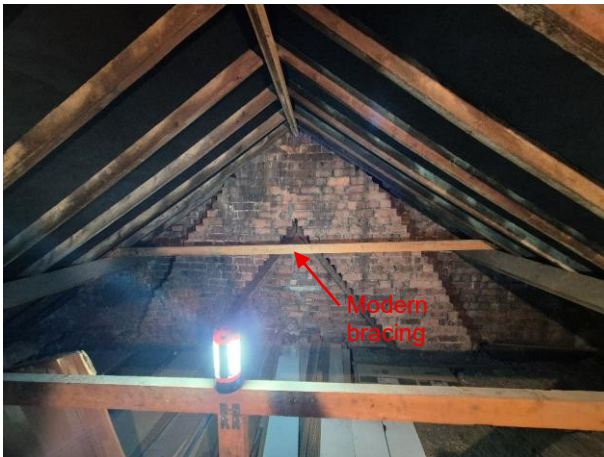
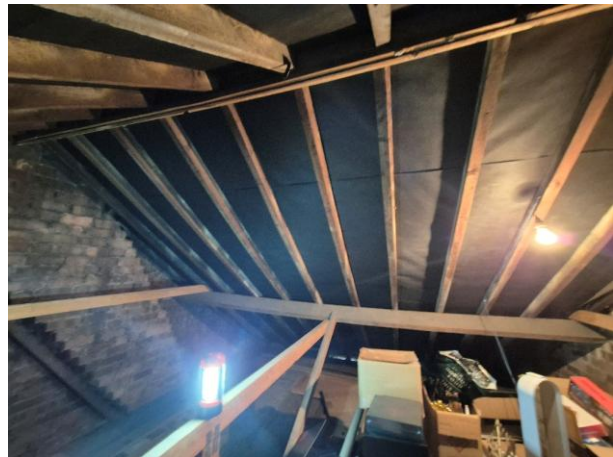
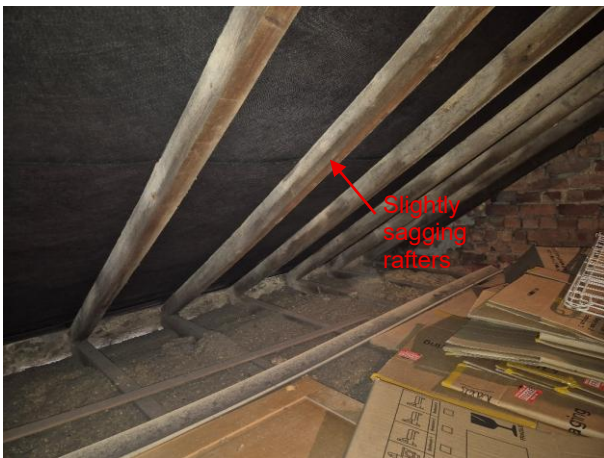
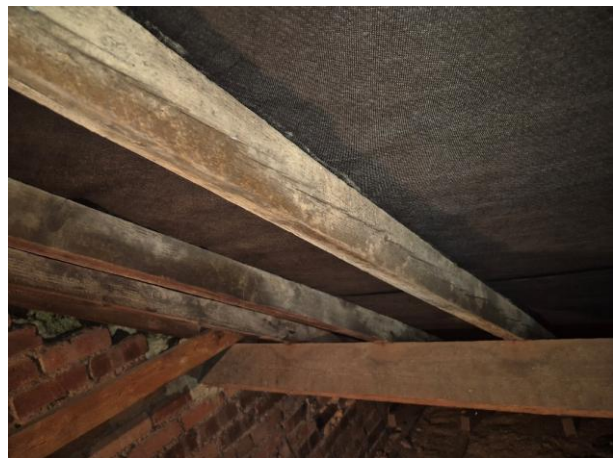
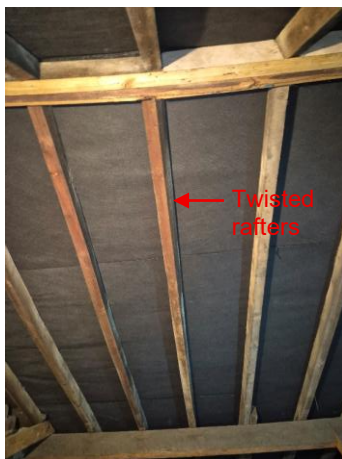
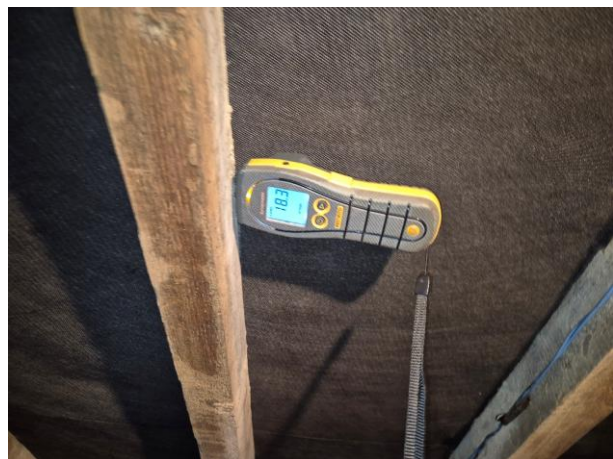
- The roof timbers show widespread staining consistent with condensation forming within the roof void. Moisture readings to the accessible timbers were not significantly raised at the time of inspection, but the inspection was carried out in late spring and the readings may not reflect winter conditions, when condensation risk is typically higher. The roof has a modern breathable membrane below the tiles; however, this appears to be an earlier type of breathable underlay and there was no clear evidence that the roof void is being effectively ventilated.

- The loft insulation is currently relatively thin, which is thermally poor but may be allowing enough heat from the accommodation below to help keep the roof void warmer and reduce current condensation levels. If the insulation is upgraded without also improving roof void ventilation, the roof void is likely to become colder, increasing the risk of condensation, higher timber moisture levels, decay and further distortion of the already stressed rafters.

- Overall, the roof is not in obviously failed condition and has remained serviceable since being re-covered approximately 20 years ago. However, there is a combination of increased loading, timber distortion, split/twisted rafters, ad hoc strengthening and condensation staining. This means the roof should be regarded as carrying a higher-than-normal risk of future movement and moisture-related deterioration, particularly if insulation is upgraded or if ventilation is not improved.

| Urgency | Action |
|---|---|
| <b>A</b> | As there are cracks/splits to the rafters and some wider evidence of roof structure movement, I believe an inspection by a qualified structural engineer prior to purchase would be advisable. The engineer should comment on the suitability of the current roof structure for the load of the concrete tiles, particularly considering its current condition. This inspection should be carried out in tandem with that recommended in <a href="#">Section D10</a> . |
| <b>C</b> | You may wish to consider upgrading the loft insulation to a minimum 270mm thickness, which complies with modern Building Regulations standards. This will help to reduce energy bills and keep the home feeling warmer. As this will result in the loft space being colder, you must also ensure that ventilation to the loft is improved at the same time so that moist air can be removed before causing condensation issues. |

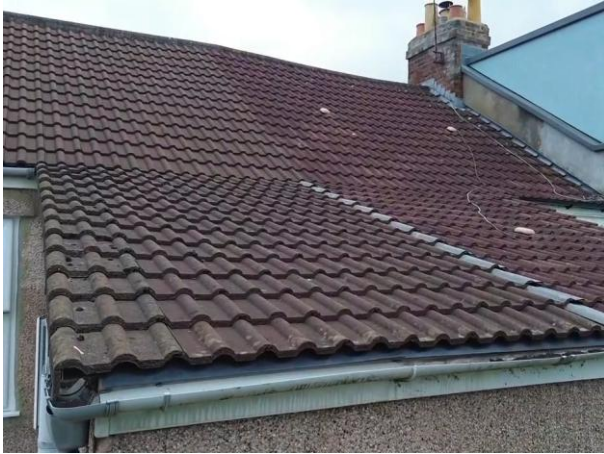
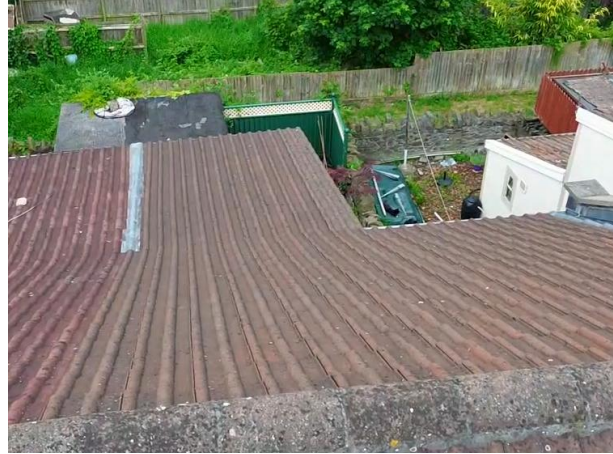
#### Rear projection roof:

- Externally, this roof appears in fair condition. However, the structure and underside of the coverings could not be seen from inside as there are ceilings fixed to the rafters.
- I would expect the insulation to this roof to be fairly minimal, which could mean that the rear bedroom may suffer from excess heat loss.
- This roof would also have been originally covered with lightweight tiles, and is now covered with concrete tiles. I would expect this to create issues similar to the main roof as described above.

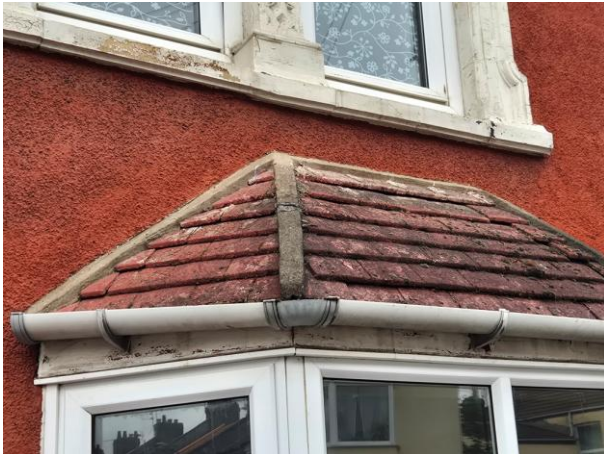
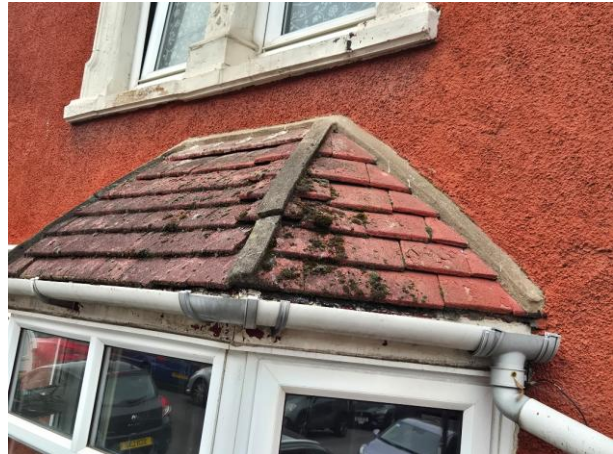
#### Front bay roof:

- The cement ridge pointing to the front bay roof is cracked and damaged, which could lead to a small amount of water ingress.

| Urgency | Action |
|---|---|
| <b>C</b> | I recommend removing the cement ridge pointing to the front bay roof and installing new hip ridge tiles and lead flashings between the roof coverings and the front wall. |

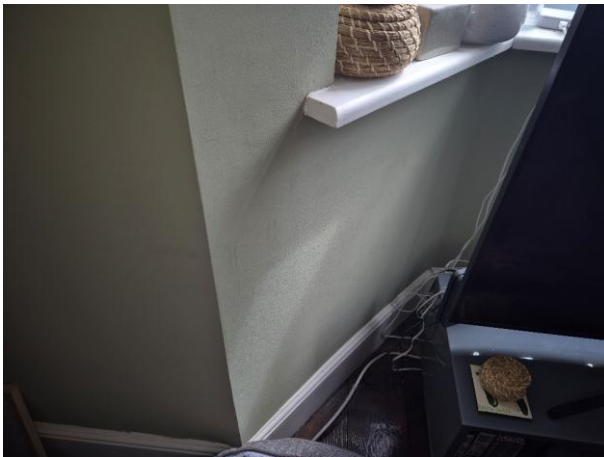
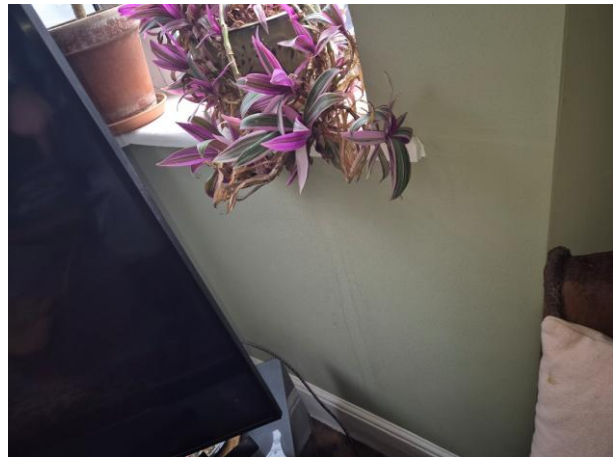
- There are some small cracks to the front bay window under the cill in the lounge and externally. The front bay appears to have been replaced at some point, although the vendor was unaware when this was done. The bay structure and foundations are separate to that of the front wall of the house, so a slight amount of seasonal movement is to be expected, and I believe the cracks present have resulted from this. I have not seen evidence of significant movement or structural issues, so no remedial work is required other than cosmetic filling and redecoration.

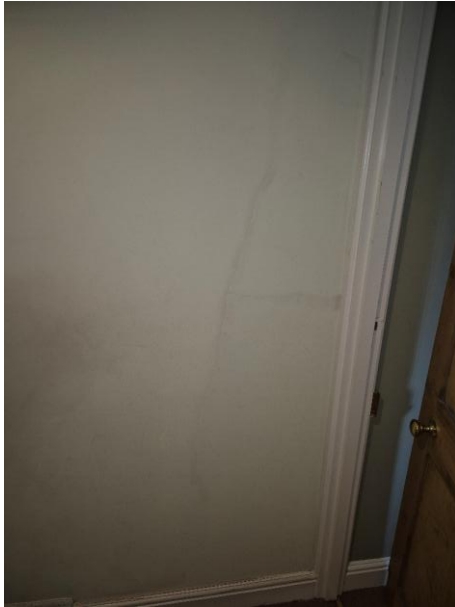
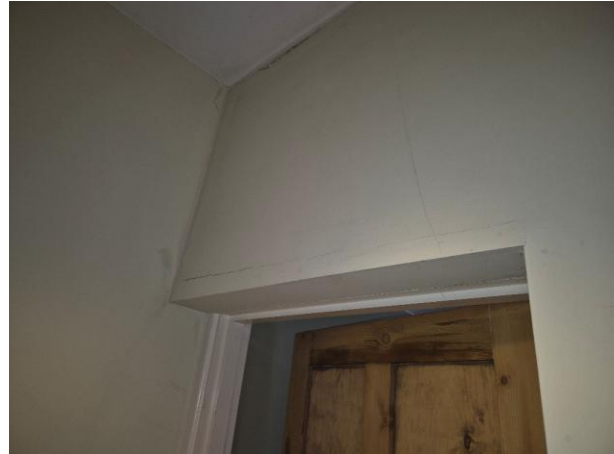
- The rear projection part of the building has historically suffered from minor subsidence. I have seen a copy of a Certificate of Structural Adequacy from June 2008, which demonstrates that remedial works were undertaken and validated as sufficient to prevent further damage. There are some old cracks in the rear hallway and around the rear bedroom door which appear to be related to this. I have seen no evidence of ongoing movement or issues.

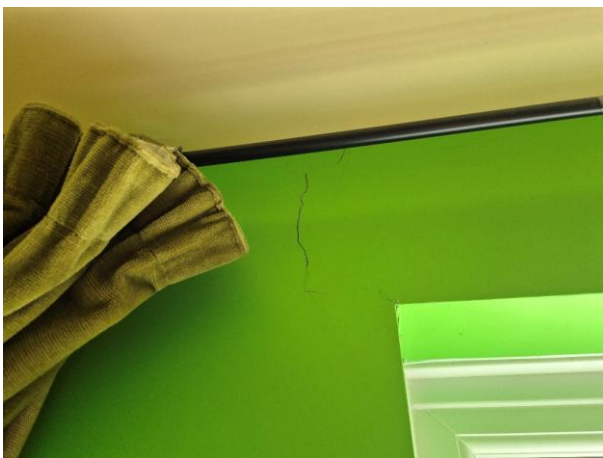
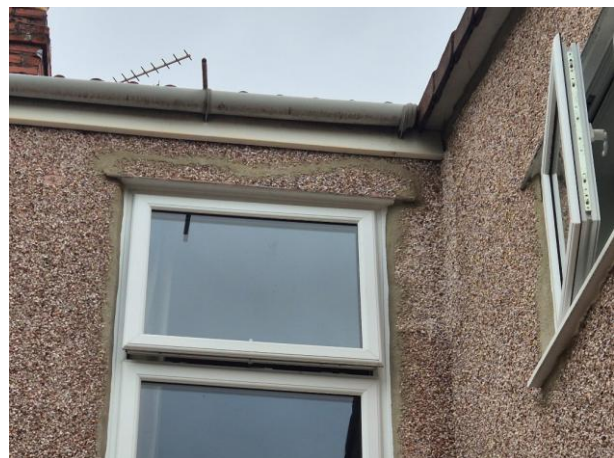
- There is a moderate (1-2mm wide) crack above the middle bedroom window. This corresponds with some historic repairs to the external render on the rear elevation, which has not re-cracked. There is however a possibility that the internal crack may be related to some movement of the roof structure above, although it does not appear severe or structurally significant at this time. No repairs are required other than cosmetic filling and redecorating. However, if any further cracking is experienced here, you should seek further advice from an experienced builder or structural engineer.

| Urgency | Action |
|---|---|
| <b>A</b> | I recommend instructing a qualified structural engineer to assess the cracking to the party walls and the top left of the rear elevation and provide advice on causation, seriousness, and remedial works. This should be assessed in line with the issues also discussed in <a href="#">Section D10</a> . |

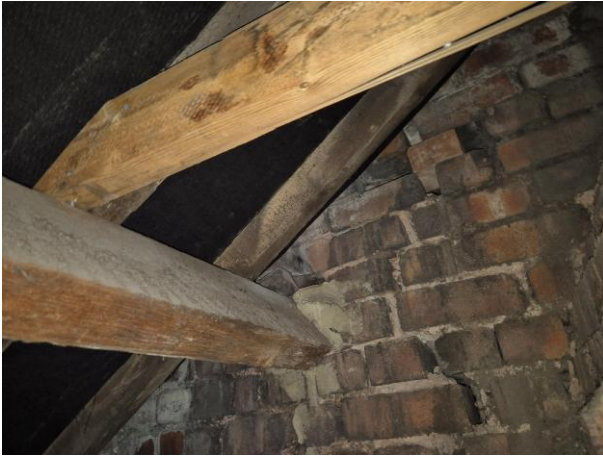
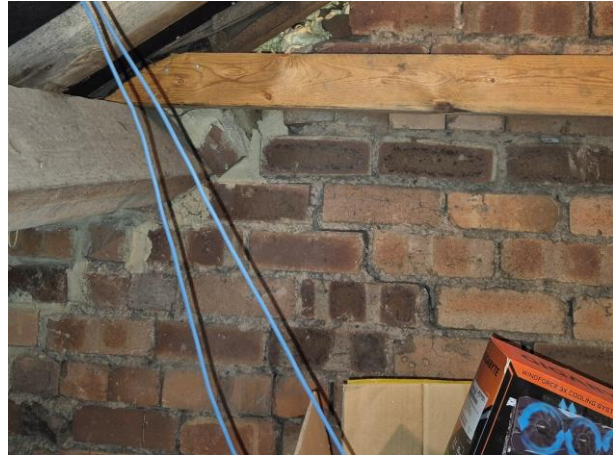
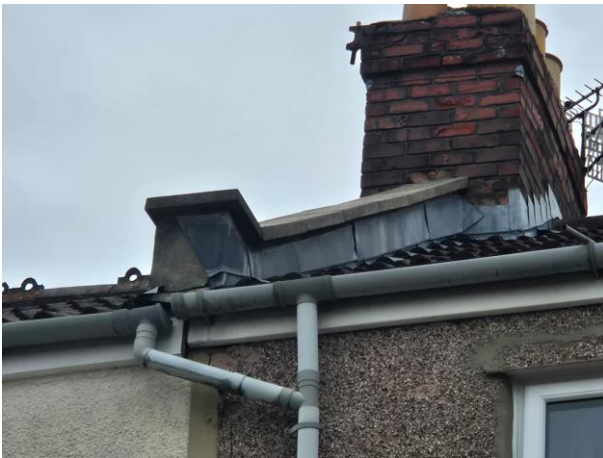
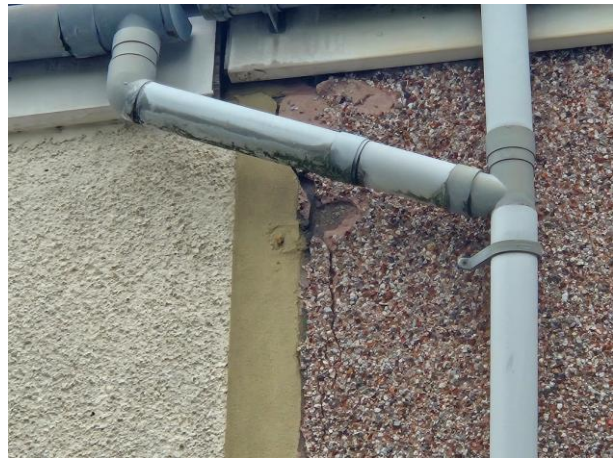
- In the loft, there are cracks to the mortar joints of the party walls, particularly beneath the bearings of the purlins. These appear fairly old, but are likely to signify some movement of the roof structure. These should be considered by the structural engineer when investigating the issues identified in [Section D10](#).
- There is also some cracking on the rear elevation at the junction between the rear wall and the party wall, which may be related to the cracking / damage to the party wall inside the loft. I am concerned that there is a risk of continuing structural movement here causing worsening cracking and potentially localised instability.

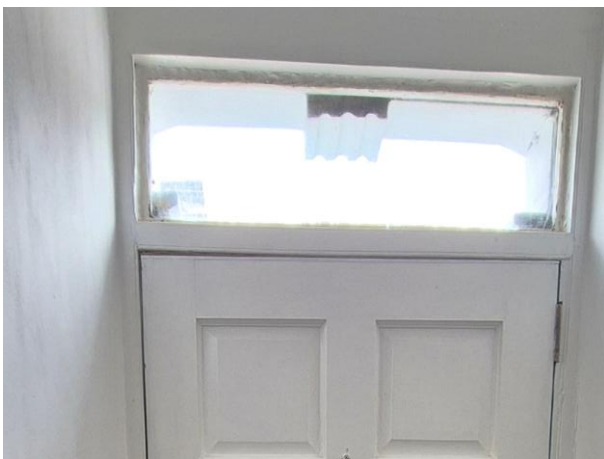
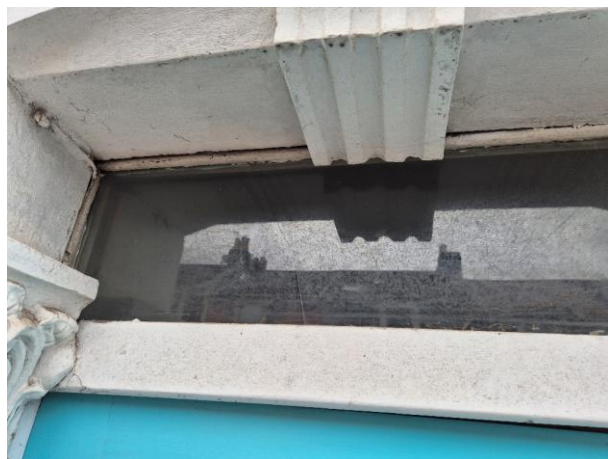
- The front door opening is slightly out-of-square, resulting in there being slight gaps around the door which will allow draughts. The glazed fanlight above this door is also cracked. These issues indicate that there has likely been some slight movement to the front of the property at some stage, although I don't believe this is recent or ongoing.

- The opening casements to first floor bedroom windows are not sufficient provide an acceptable means of escape to comply with current Building Regulations. There is no retro-active requirement to replace these windows with compliant units, although the next time the windows are replaced, a window of compliant dimensions and specification must be installed. You may also wish to replace the windows on first floor to meet this safety requirement.

- The sealant around the window/door openings externally was noted to be in poor condition in places. This can lead to water ingress at these junctions.

| Urgency | Action |
|---|---|
| <b>C</b> | Sealant to all window and door openings should be replaced soon with new external grade mastic sealant to the full perimeter of the opening and cill. |

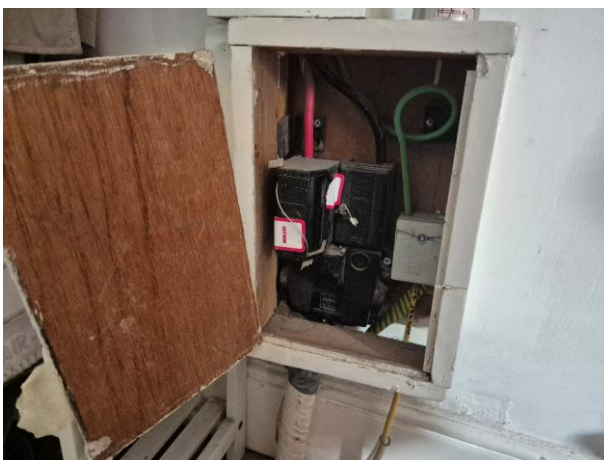
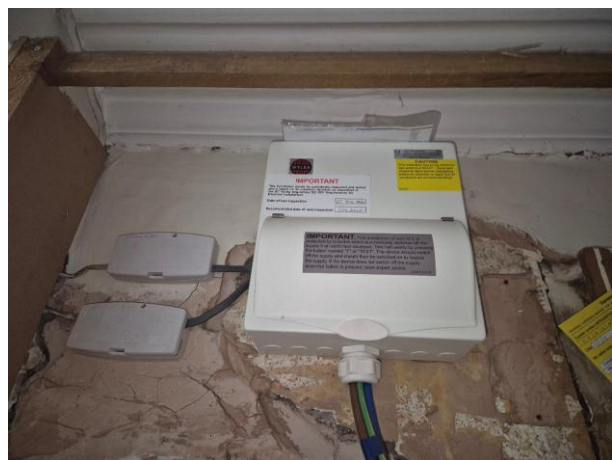
- The label on the consumer unit states that the next electrical inspection was due in July 2025, therefore although I have not seen anything to suggest the installations are in a dangerous condition, I cannot confirm that they have been checked for safety recently.
- Where the electricity supply enters the building, the main cut-out fuse (service head) is encased in a black plastic material known as phenolic. The insulating material inside these fuse carriers can break down with age, resulting in overheating and fires. This is a fire safety hazard and should be addressed soon.

| Urgency | Action |
|---|---|
| <b>A</b> | You should arrange for a NICEIC (or other Government approved body) registered electrician to carry out a full Electrical Installation Condition Report (EICR) for the property before exchange of contracts. This will allow you to know what any required repairs/upgrades will cost before committing to the purchase. |

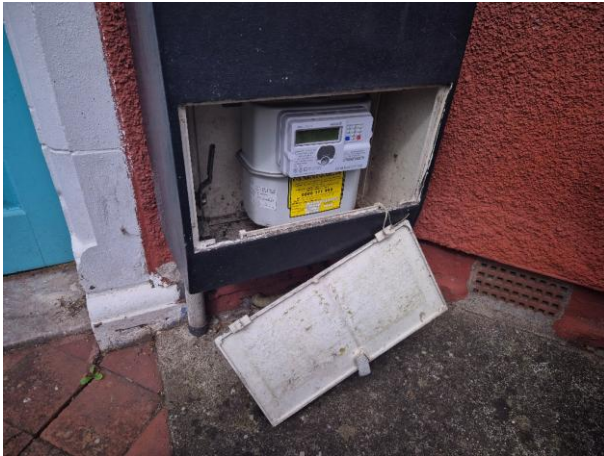
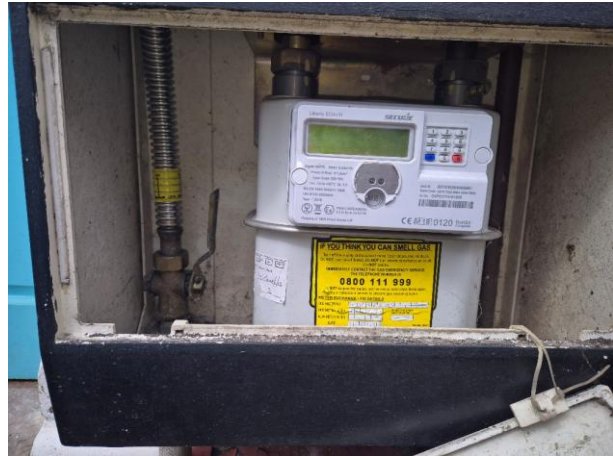
- I have not seen a gas safety certificate for the property from within the last 12 months so cannot comment on the safety of the gas installations.
- I could see no evidence of any protective electrical bonding which is required to help protect against occupants receiving electric shock from the gas pipework should any faulty electrical cabling cause the pipework to become live.

- The gas meter cupboard door is damaged. This can result in the door falling off in high winds, leaving the meter exposed to weather damage etc.

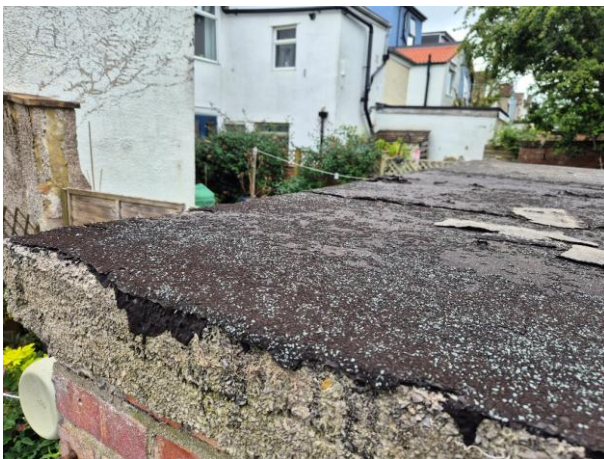
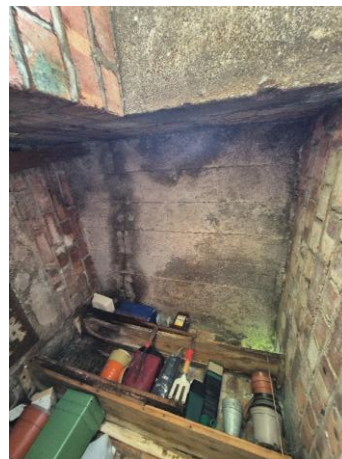
The outbuilding is generally in fairly poor condition. The following defects / issues were identified during my inspection:

- The timber door has been removed and is beyond repair.
- The bitumen felt flat roof coverings are heavily degraded and are no longer functional. This will allow water to penetrate through the concrete roof slab, likely leading to corrosion of the reinforcement bars. There is some cracking of the concrete inside the outbuilding, so I believe this process is likely already started, although it is not currently detrimental to the roof's structural integrity.

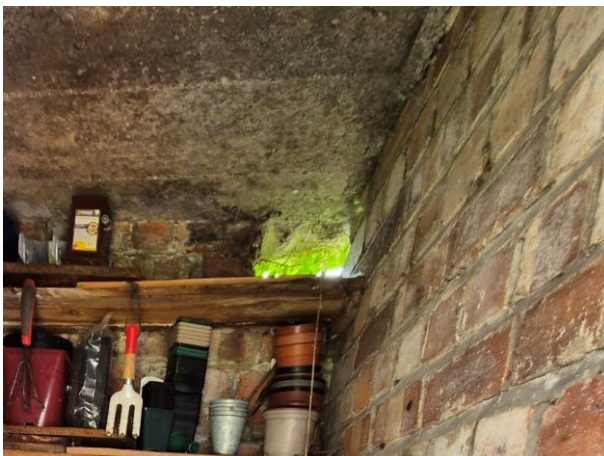
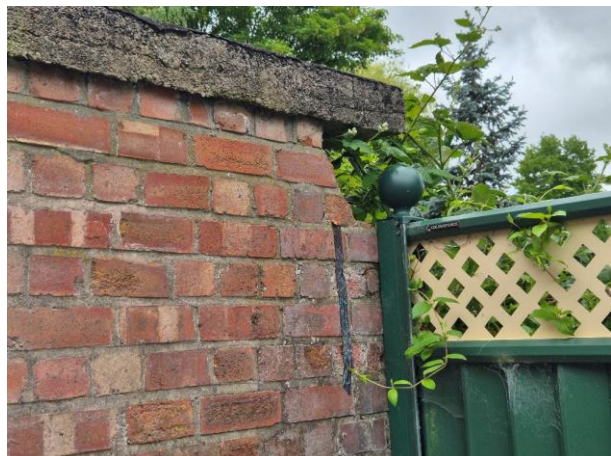
- There is a section of brickwork missing from the top rear corner of the outbuilding. This will allow water ingress which could damage stored belongings, but can also allow rodents, wasps etc to enter the outbuilding.

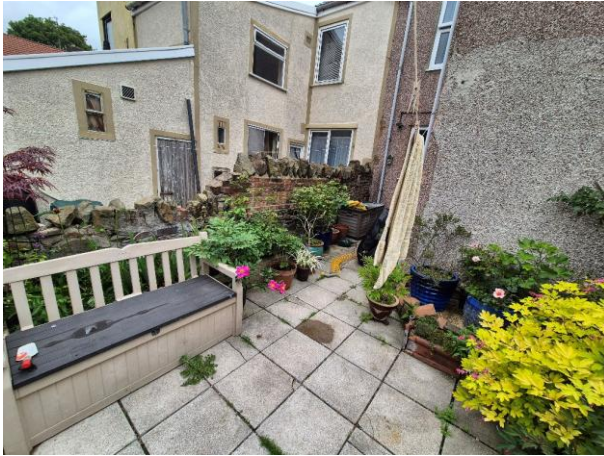
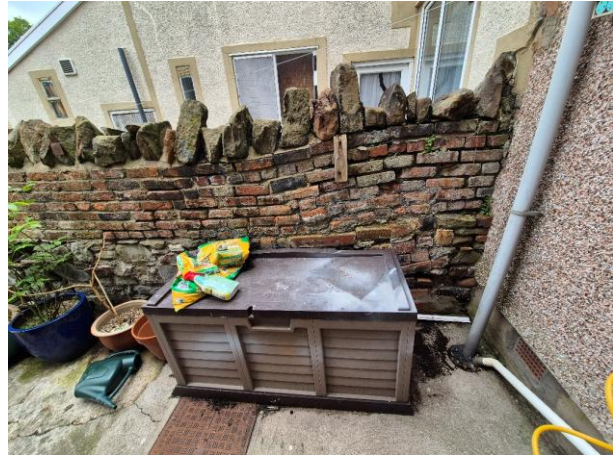
The external areas forming part of the property are generally in fair condition. The following defects / issues were identified during my inspection:

- The low brick wall to the left of the front garden has a section of cracked and loose brickwork by the gate, which appears to have been from impact damage.
- The brick and stone boundary wall in the rear garden is uneven with some heavily degraded mortar joints, which could lead to some areas of brickwork becoming unstable.
- The patio area has degraded pointing between the slabs with a lot of weed growth forming in the gaps. This has the potential to loosen slabs and cause trip hazards.
